CAMELOT

Client: David Hermitte and Sandrine Hazan
Inspection Address: 583 Cypress Street, Monterey, CA
Inspection Date: 2/9/2009 Start: 10:30 am End: 2:00 pm

HOME INSPECTION REPORT

For the property located at
583 Cypress Street, Monterey, CA

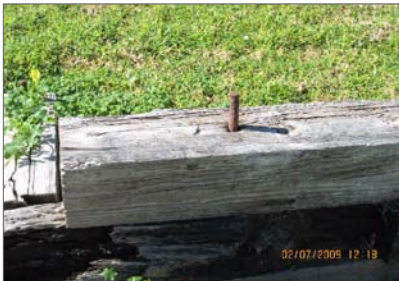
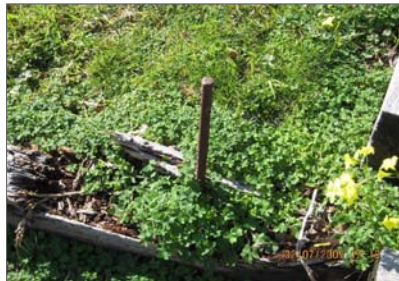
1.5 - There are embedded steel rods in the rear (south) yard walls that represent a potential hazard that should be removed or cut flush to the surface for safety.

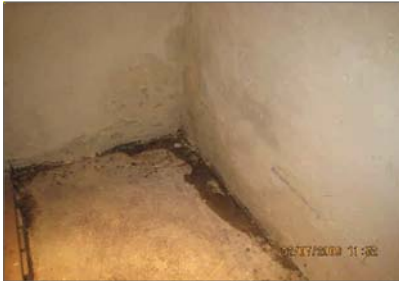
1.9 - There are areas of living space that are below grade and susceptible to moisture intrusion. The exterior/crawlspace foundation walls have not been coated or lined with waterproofing compounds, and there is evidence of active water intrusion (most notably at the lower west room at base of stairs). We recommend that you have this condition evaluated by an appropriately qualified geotechnical engineer prior to the close of this transaction.

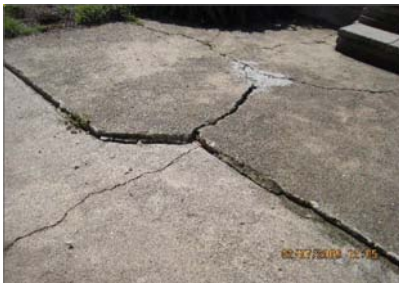
1.11 - The concrete patio at the south side of the home is heavily cracked and/or damaged, and needs service.

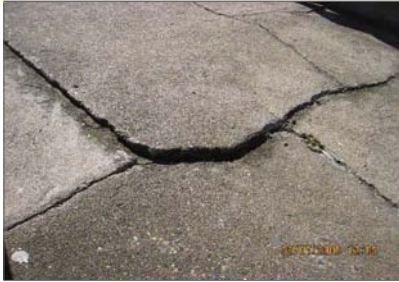
1.12 - There are offsets in the south concrete patio that could prove to be trip-hazards that you should

have repaired/services for safety reasons.

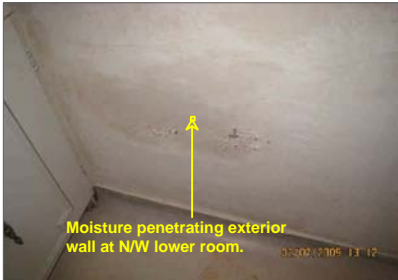
2.6 - The protective membrane at the north exterior stairs and landing is cracked and leaking into the crawlspace and penetrating the exterior walls below them. The stairs and landing will need to be recoated/sealed, and you should have them evaluated by an appropriate specialist for further remarks and recommendations.

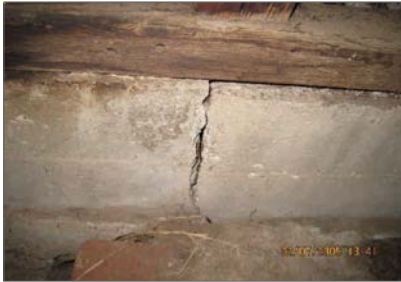
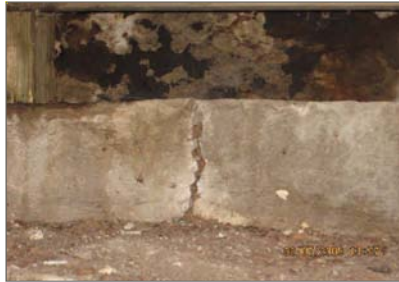
3.8 - There are cracks or fractures in the concrete foundation stem walls in several areas. These cracks typically result from movement of some type or another, and their discovery is not all that surprising given that the structure is located on a hillside with poor drainage and grading conditions. Also, the concrete used in foundation walls constructed in the 1920's-1930's has a tendency to weaken (even soften and deteriorate) over time due to its lime content. However, because older foundations such as this one can be difficult and costly to retrofit, it should be evaluated by an appropriately qualified structural engineer for further remarks and recommendations prior to the close of this transaction.

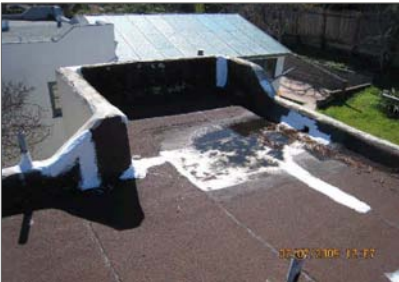
4.2 - The built-up asphalt roof covering is heavily patched in some areas (S/E corner). This may indicate past leakage, but this can only be confirmed through disclosure by the seller(s) and/or by having the roof tested for watertightness. In any event, the repairs appear substandard/amateurish, and there is water pooling/evidence of poor drainage, and you should have a licensed roofing contractor evaluate the roof covering for further remarks and recommendations.

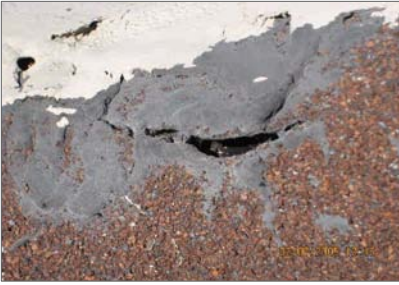
4.3 - There are open seams or splits in the mineral cap-sheet of the parapet walls that should be sealed.

There are open seams or splits in the mineral cap-sheet of the parapet walls that should be sealed - *Continued*

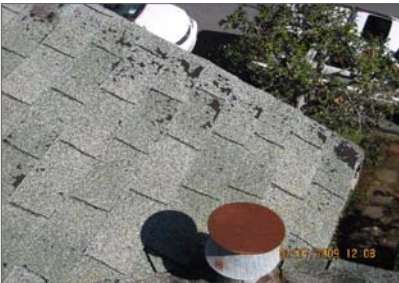
4.6 - The composition shingle roof has some deterioration and shows wear in some areas that is consistent with the relatively advanced age of the covering. The covering appears to be approaching the end of its serviceable life and should be monitored regularly. The need for early replacement should be anticipated.

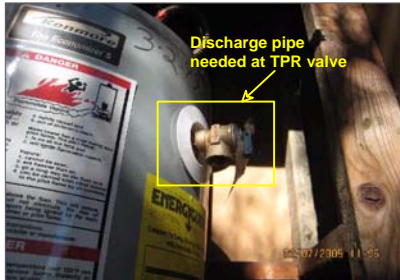
6.30 - There is no discharge line on the water heater T&P relief valve, which represents a potential scalding hazard and which can result in water damage should the valve ever leak. One will need to be installed and made to terminate at a visible location at the exterior of the home and within six inches of the ground.

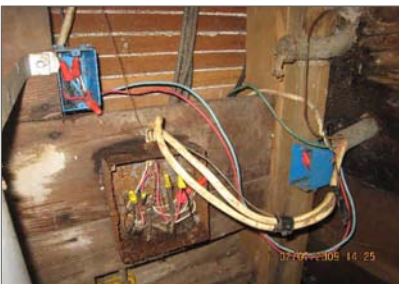
7.12 - There are open electrical junction boxes within the crawlspace that should be sealed to contain any arcing or sparking would be contained within the box.

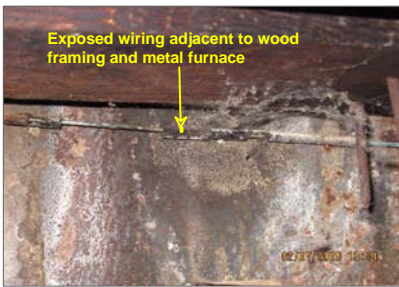
7.14 - Obsolete and potentially hazardous knob-and-tube wiring (deterioration of insulation, close proximity of exposed wiring to wood framing and metal furnace) is present within the crawlspace and this older wiring should be evaluated and serviced immediately by an appropriately qualified and licensed electrician for safety.

Obsolete and unsafe knob-and-tube wiring is present within the crawlspace and should be evaluated - *Continued*

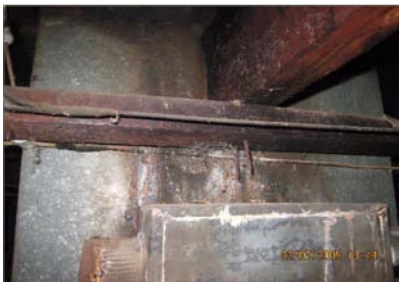
8.3 - Heat is provided by a floor furnace. Such furnaces are among the oldest and least efficient of heating systems. However, there is evidence of rust and metal fatigue within the combustion chamber, and the furnace is too close to combustible wood framing, and for safety reasons we cannot endorse it. We recommend that you have the furnace evaluated by an appropriately qualified heating contractor for further remarks and recommendations.
